The Fourth Little Pig Built His House with ICF

**SI[®] Concrete Systems**

Greg Moody – May 12, 2003

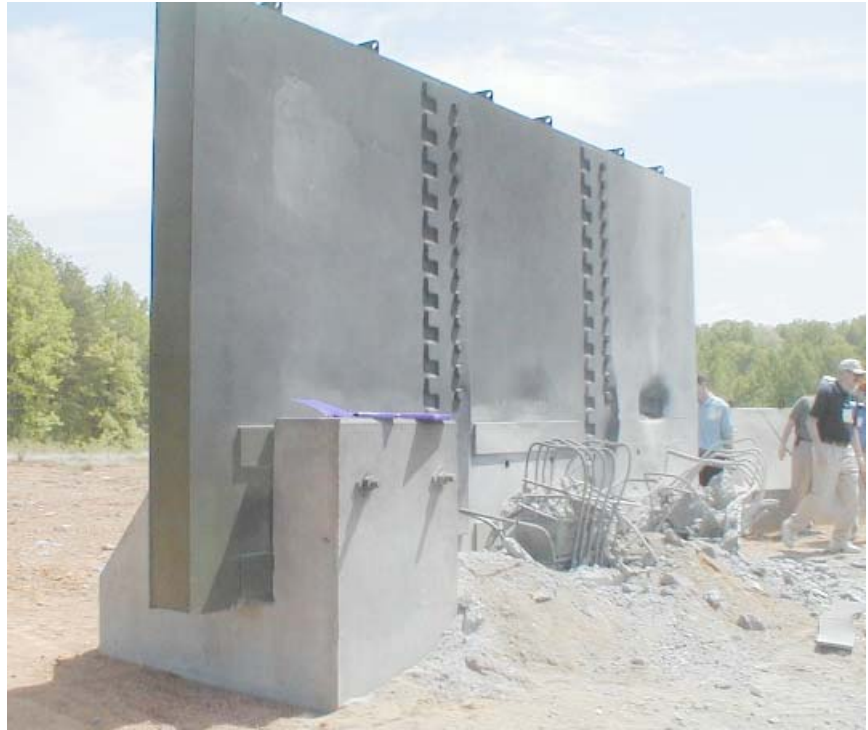
Figure 2 – Since the TNT charge decimated the concrete bolster on which it was sitting, the TNT charge was placed on a different bolster each day. This photograph was taken after the second day. The bolster to be used on the third day can be seen in the foreground. (The charge will be placed where the blue folder in the photograph is located.) The remnants of the bolsters used on the first and second day can be seen along the center and right side of the wall. The rebar in the bolsters is #7. Damage to the blast wall itself can also be observed behind the sites of the first and second charges.

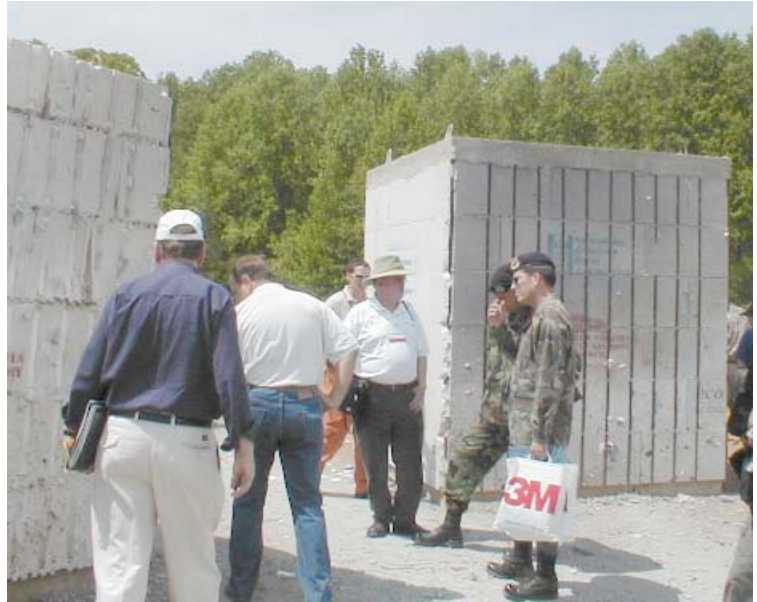
The EPS cover is a major reason for the superior blast mitigation of the ICF system. Evidence of the EPS compressing could be seen in all specimens. As the specimens came closer to the charge and the blast force increased, the compression of the EPS became more pronounced. This compression dampened the force of the airblast and absorbed a considerable portion of the blast energy.

Figure 4 – Specimens C (left) and D (right). Signs of compression of the EPS can be seen in the wall facing the blast of Specimen D. (Note how the ribs are only seen on the side facing the blast.) Embedded shrapnel can be seen on the bottom of Specimen D. Also, although exposed, no damage was seen to the edge of the upper slab.

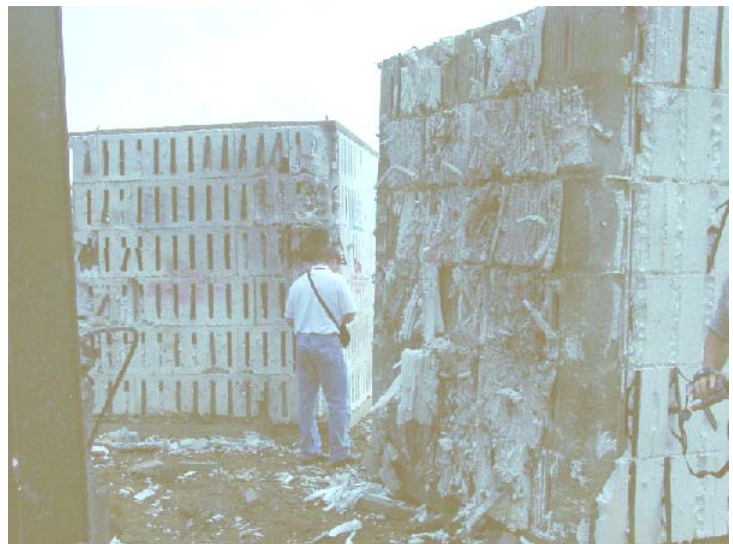
After each test, the specimens were thoroughly evaluated. After the EPS (Extruded Polystyrene or foam) was assessed, portions of the EPS were manually removed so that the underlying concrete could be evaluated. None of the specimens experienced catastrophic failure; in fact all the assemblies were readily lifted by the crane after the demonstration. The only damage to specimens A and B (the farthest two specimens) was the EPS peeling away at the corners. Specimens C and D displayed minor distress to the foam, but no damage to the concrete was observed. It was only after the standoff distance was reduced to a mere 10' were cracks observed in the concrete. None of the cracks exceeded 2 mm across. Chunks of concrete were dislodged from Specimen E, the specimen at the 10' standoff distance. (See Table 1.)

Figure 5 – Specimens D (left) and E (right). Specimen E had the closest standoff distance to the charge. The EPS was severely damaged, but the concrete maintained its structural integrity.

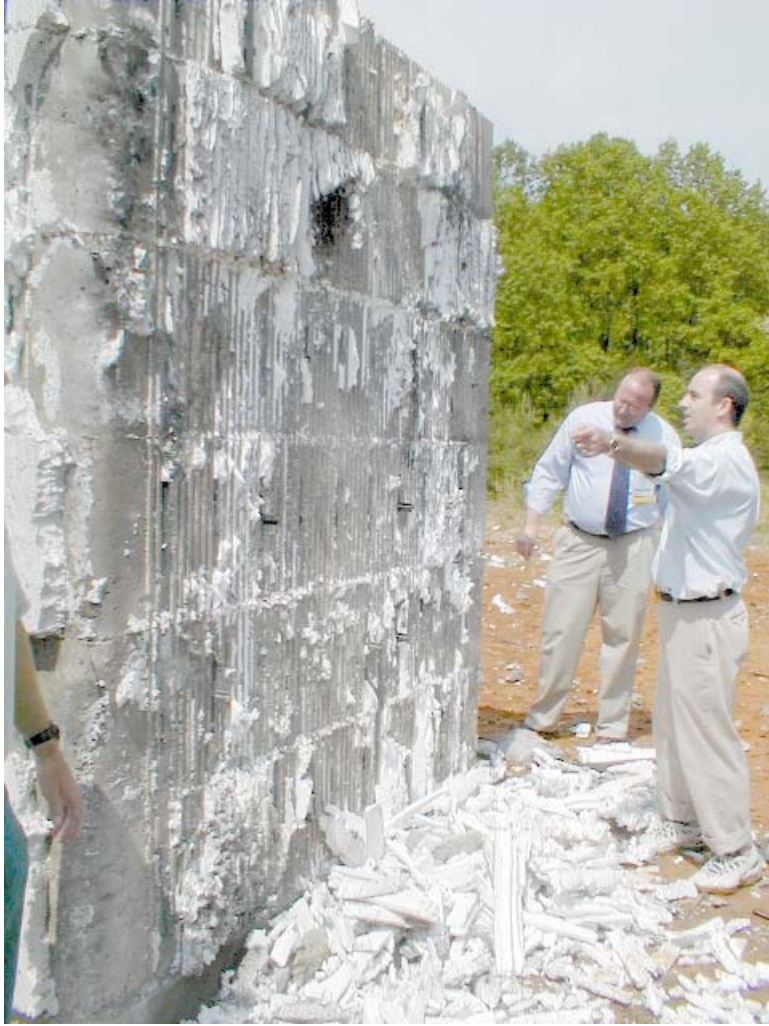
Figure 6 – Evaluation of Specimen E after the EPS was manually removed to expose the underlying
